Electroluminescence (EL) of photovoltaic modules – Terms and classification

VDE SPEC 90031 V1.0 (en)

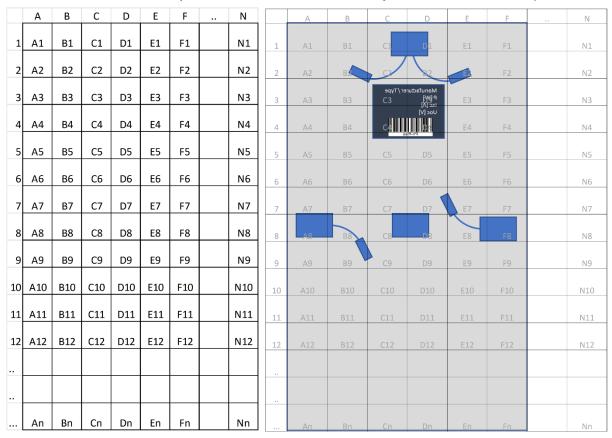
Figure 1 – Cell location / position nomenclature. View from frontside – left as e.g. visible in EL/visual inspection, right look through to locate junction box(es) and nameplate sticker

To locate cells in the module the nomenclature in Figure 1 applies. It considers different cell geometries as well as different internal circuitries of the PV module. An example is given in Figure 2.

Base scheme: cell positions Base scheme: junction box + nameplate

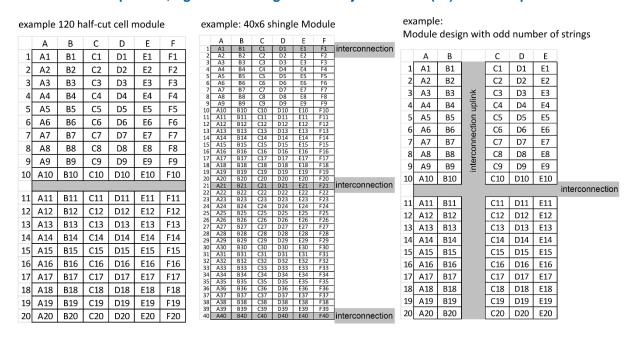
Figure 2 - Example layouts of different module designs

Contemporary module designs often consist of a combination of serial and parallel connected substrings. A common module configuration for instance consists of 3 submodules connected in series, each with two substrings connected in parallel.

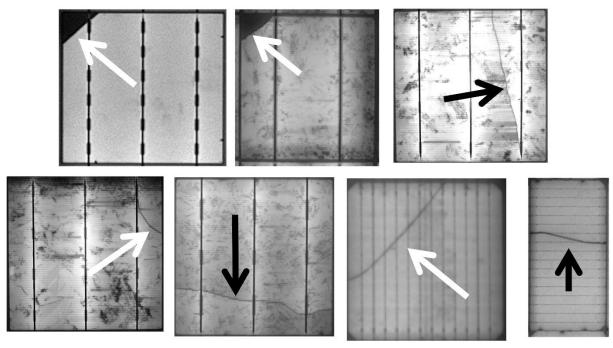
Figure 3 – Complete single crack

Definition: A single crack within a single solar cell that is complete.

Possible root cause of defect: cell and module handling, mechanical loads.

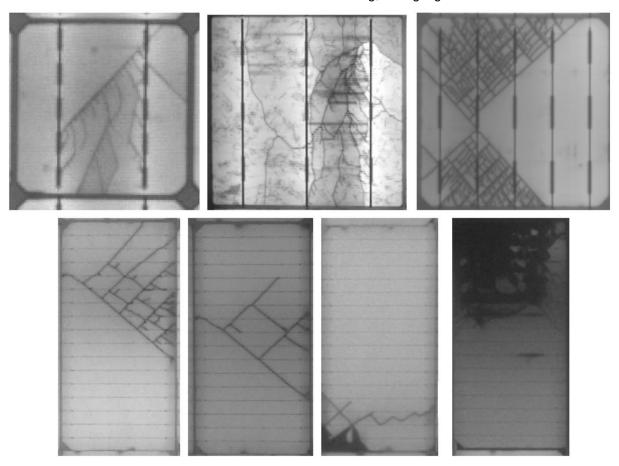
Figure 7 – Multi / Dendritic shaped crack structures

Definition: dendritic/branching looking crack pattern across the full cell.

Possible root cause of defect: bad cell and module handling, strong/high mechanical loads.

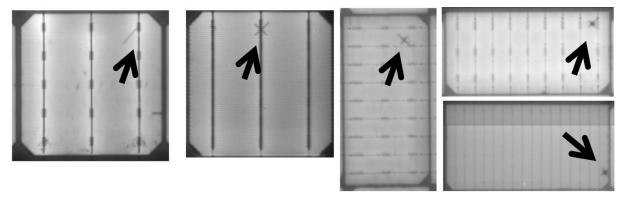
Figure 8 - Tiny X-V-shape cracks

Definition: Short cracks (<30mm total length) within the solar cell, not crossing a BB and not ending at edge of cell, often start at BB or cell cut at position of BB, show 45° angels with respect to BB.

Possible root cause of defect: typically cell / string handling during manufacturing, tiny x-shape cracks can be caused by sharp tools from hitting the backsheet.

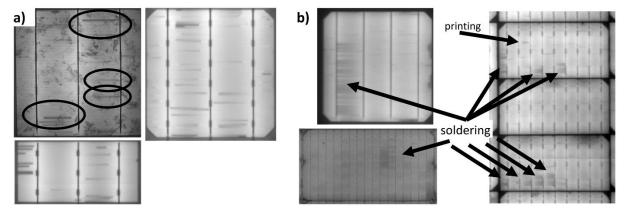
Definition: Solar cell grid finger interruptions, typically a few per cell, repeated in neighbouring cells.

Possible root cause of defect: defective mesh during cell printing; miss-aligned ribbons vs BB during soldering.

Figure 9 – Example images of finger interruptions
a) typically caused during cell metallization printing
b) interruptions at busbar possibly caused by misaligned ribbons on cell during soldering.

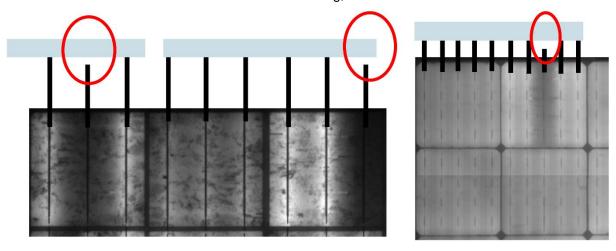
Figure 10 – Examples of missing (or broken) solder bonds to cross connector

Definition: Solar cell interconnection not connected, e.g. by missed soldering or to short cell interconnection ribbon.

Possible root cause of defect: bad or missed soldering, cell connectors too short.

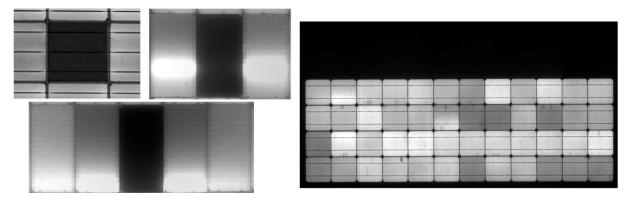
Definition: totally dark cell or (double)cell-string (no PID).

Possible root cause of defect: shorted cell during stringing, defective bypass diode.

Figure 11 – Completely dark cells during defects in electric circuitry. left: shorted individual cells within a string, right: shorted bypass diode that reduced module output to 2/3

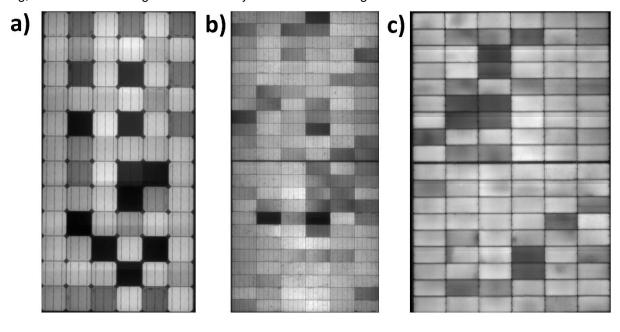
Figure 12 – Example images of
a) PID b) LeTID c) UVID

Definition: totally affected cells with dark or darker grayish appearance.

Potential root cause of patterned image: Potential induced degradation (PID), Light and elevated temperature induced degradation (LeTID), UV-induced degradation (UVID), or mixing of cells with different efficiencies. PID, LeTID, UVID pattern are typically visible after outdoor exposure or stress testing, whereas cell mixing is visible directly after manufacturing.

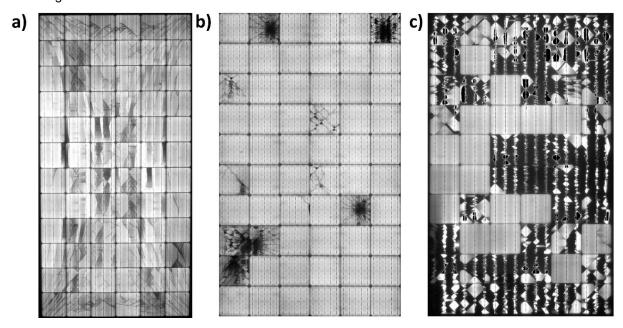
Definition: Severely cracked cells with special pattern, originated from different types of strong mechanical impacts.

Potential root cause of defect: Severe snow loads (a), hail impact (b) or severe impact, including broken glass.

Figure 13 – Example images of
a) severe homogeneous applied static load
b) Point-like loads caused by impact such as larger hail
c) severe impact with glass breakage

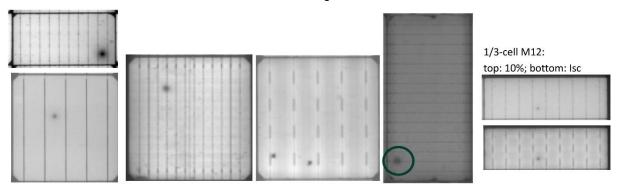
Figure 14 - Dark spots on different cell formats and cell cuts

Definition: Tiny dark areas (mm-range), typically circular in shape within the solar cell, no known impact on long term stability.

Possible root cause of defect: contaminations on ingot, wafer or cell level.

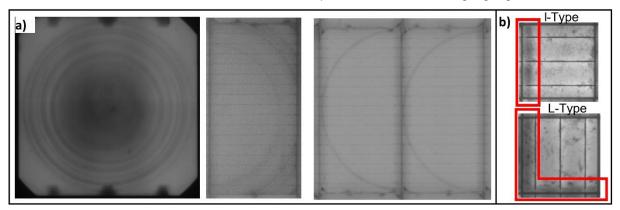
Definition: Circular rings within mono-crystalline cells, can't occur in multi-c-Si material; darker grayish areas along one or two cell edges of multi-crystalline cells, can't occur that way in mono-crystalline cells. No known impact on long term stability of AI-BSF and PERC cells, might be different for nextgen cells.

Possible root cause of defect: contaminations and process variations during ingot growth.

Figure 15 – a) Rings in the mono crystalline wafer, b) darker regions in multi-crystalline wafers (cells) caused by position of wafer in brigg

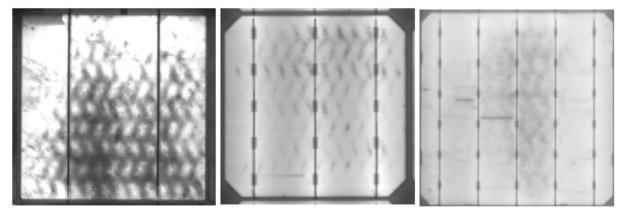
Figure 16 - Belt-like pattern, typically across the full cell

$\textbf{Definition:} \ \ \textbf{Belt-like pattern, typically across the full cell, no known impact on long term stability.}$

Possible root cause of features: non-optimal firing process during cell manufacturing.

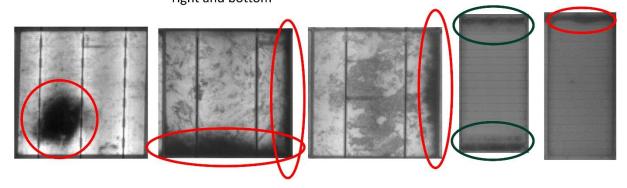
Figure 18 – Grayish und darker areas of the cell, differently shaped, different in size and brighness

Definition: Grayish und darker areas of the cell, differently shaped, different in size and brightness **Possible root cause of features:** different stages during cell manufacturing such as edge passivation right and bottom
